## PARTNERSHIP APPROACH TO BOREHOLE CLEANING DELIVERS CLEAR RESULTS

### OVERVIEW:

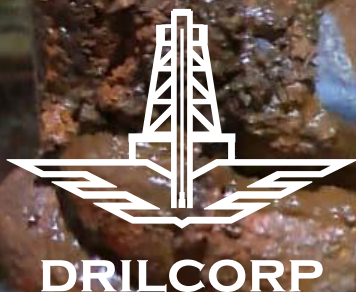
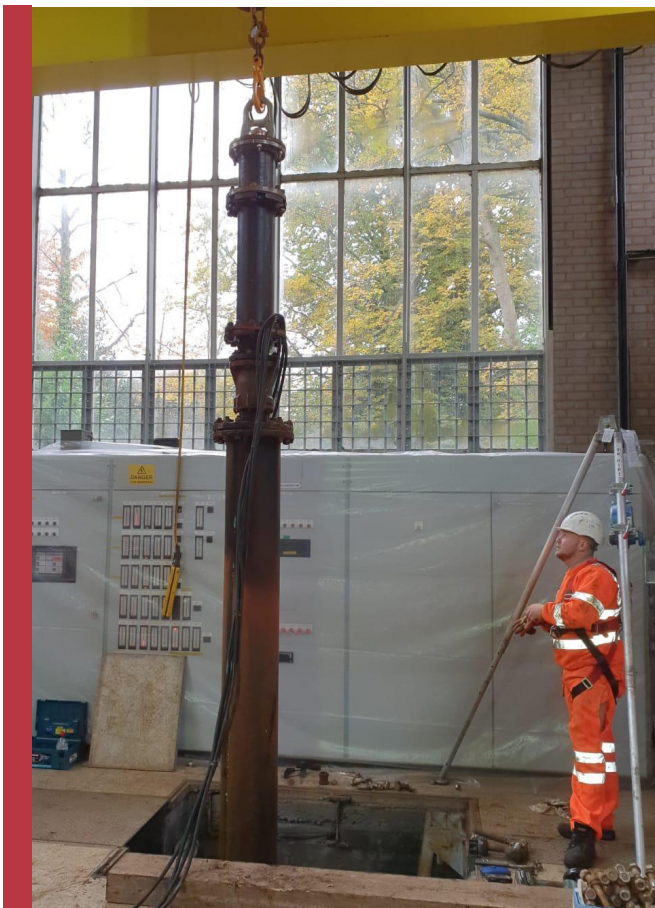
**“The Borestor uses high pressure jetting technology inside the borehole, injecting water on a spinning wheel to quickly and efficiently remove any material encrusted onto the casing. This technology not only cleans the casing, but penetrates the formation opening fractures and pores previously blocked to improve well efficiency.**

**The jetting was carried out over an eight-hour period per borehole, after which we performed another airlift to remove**

remaining debris, gathering it into tanks ready for disposal and safely pumping the wastewater into a nearby stream.”
